Manhole Inspection Summary

Manhole # S39I__024MH

Insp Date: **7/9/08 2:08 PM**

Location Address: **left side 815 president st**

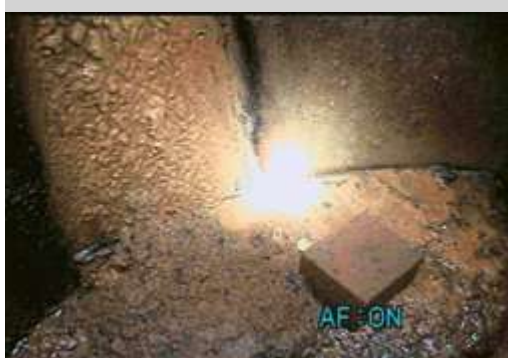
Defect 3

Condition: ☐ Sound ☐ Cracked ☐ Root Intrusion ☐ Deteriorated ☐ Leaks ☒ **Debris**

bench debris

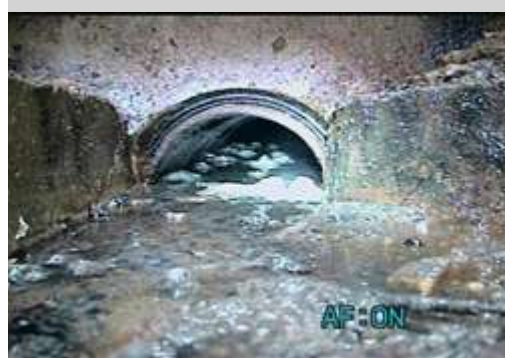
Defect 4

Condition: ☐ Sound ☐ Cracked ☐ Root Intrusion ☐ Deteriorated ☐ Leaks ☒ **Debris**

Channel Debris

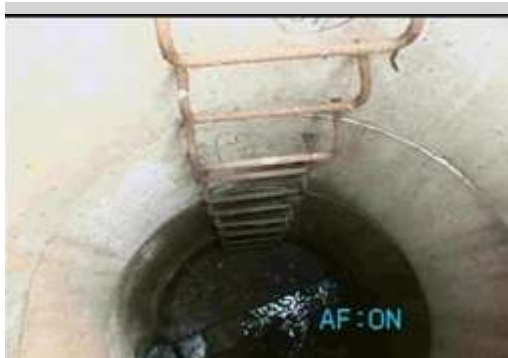
Defect 2

Steps Count: **11** Missing: **0** ☒ **Corroded**

steps

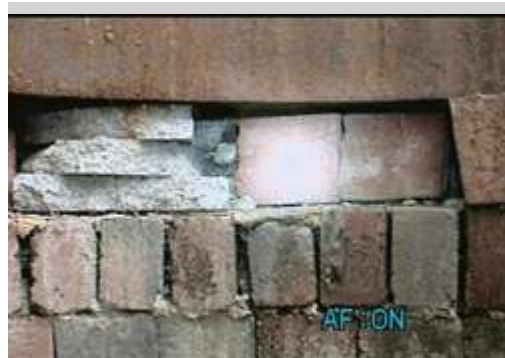
Defect 1

Condition: ☐ Sound ☒ **Cracked** ☐ Root Intrusion ☒ **Loose Brick** ☒ **Deteriorated**

cracked, loose brick, deteriorating chimney, frame adjustment
